Abbey Farmhouse, Hoxne, Suffolk

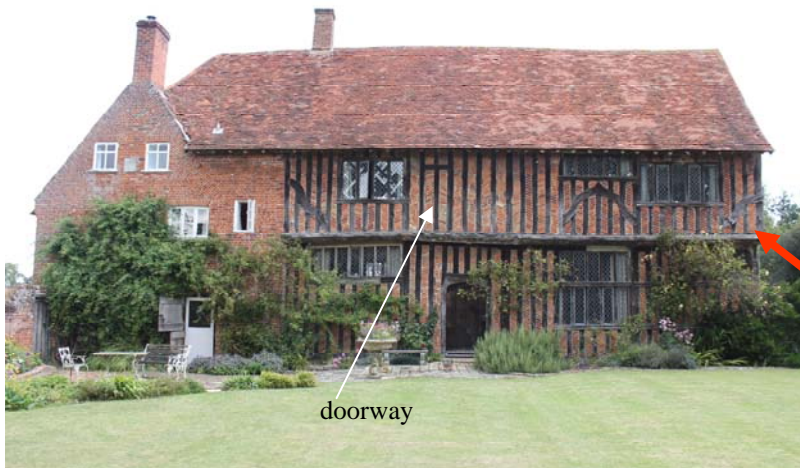
Fig 1: South front of Abbey Farmhouse

Abbey Farmhouse is a gentry house, part 16th century timber framed with a 17th century west brick crossing (Figs 1 & 6a), on the site of a Benedictine priory. In 1538, shortly before the Dissolution, the priory sold the property to Sir Richard Gresham, who a few years later in 1544 sold it to Sir Robert Southwell, who leased it to the Thurstons.

In the centre Abbey Farmhouse's timber framed range is a cross entry. Both front and rear entrances each had a two storey porch – as shown by the narrow door on the first floor on the front and back which were the entrances to the first floor rooms over the porches (Fig 1). Above these rooms there was an attic room in the roof of the porch, entered from an opening in the roof of the attic of the main range (Fig 3)¹. The porch to the south was also jettied. Today the north porch is single storey and the south one has been removed.

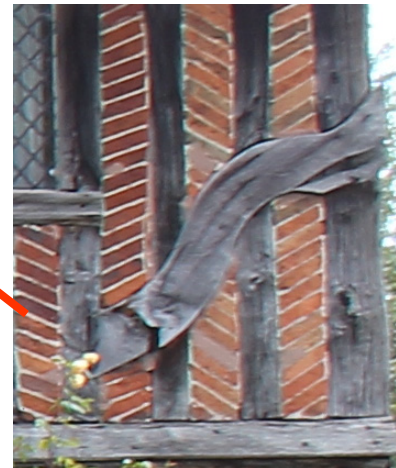
Fig 2: South east serpentine brace

The timber framing, apart from the braces in the front wall, has all the studs morticed and tenoned and pegged. The principal posts are jowled, but there is a surprising lack of braces. There are none in the north wall and none of the trusses have braces up to the tie-beams. The roof has a single clasped side purlin with windbraces on each side (Fig 3). This type of roof is usually assumed to date mainly from around the middle of the 16th century in Suffolk, but recently tree-ring dating has discovered one built over a barn in 1464/5 at Park Farm, Liston, Essex which is very close to Long Melford. So it likely that this roof was spreading through Suffolk during the first half of the 16th century, replacing crownpost and queenpost roofs. Another type of side purlin roof, a butt purlin roof, that is

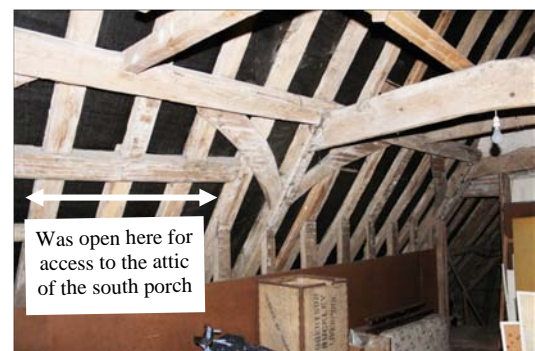
Fig 3: Roof over timber framed range
