Banham Walls - a Misnomer

At the end of 2015 HHG determined to investigate the distinctive ornamental walls found in Hoxne and the surrounding area, commonly known as Banham walls. We wanted to monitor how much they were deteriorating or disappearing with a view to encouraging their preservation.

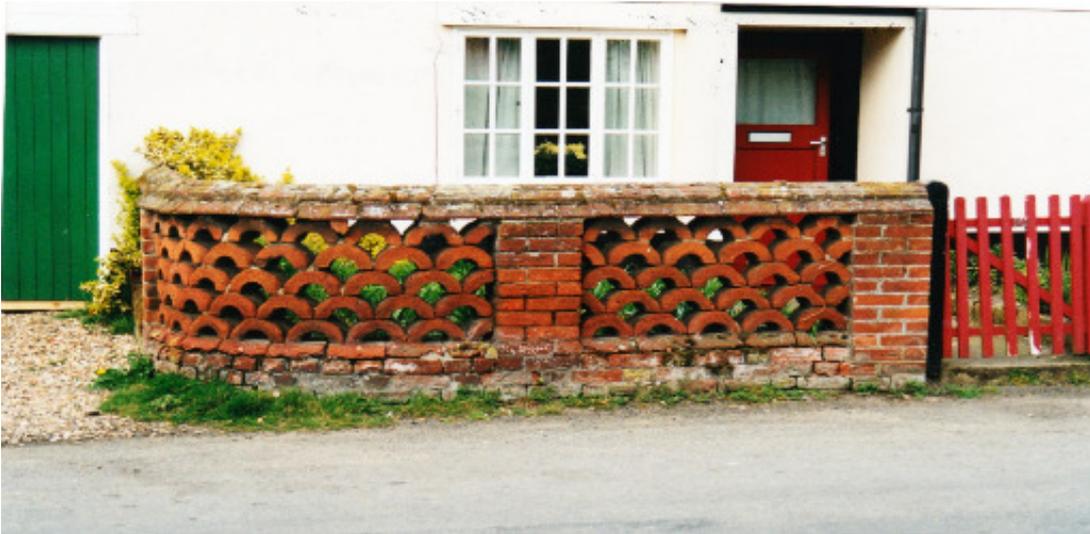
3. 10 Cross Street

There are 3 main types of ornamental wall. The simplest can be described as "halfpipe". The longest run of this type is on the north side of Cross St, Nos 6 – 12.

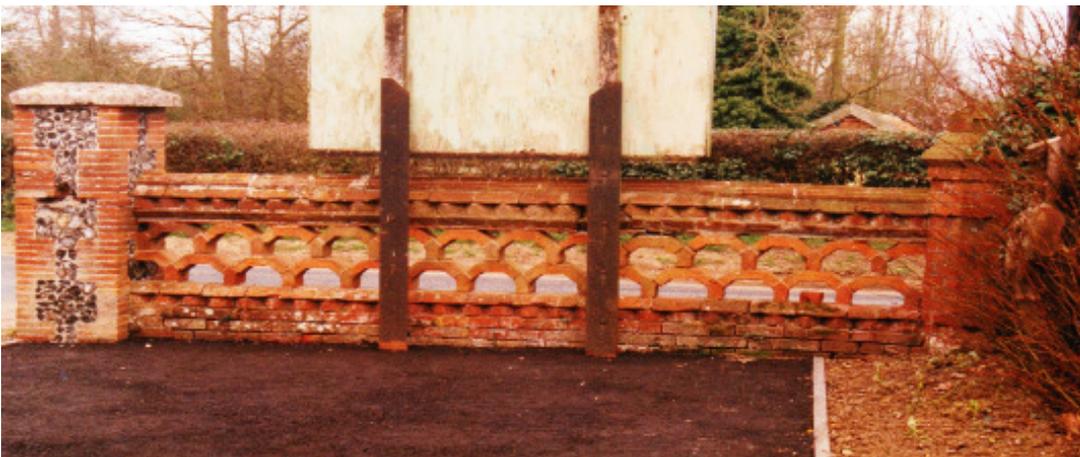
4. Village Hall

The second type, such as the wall at the village hall or 16 Cross St uses 2 different bricks to make the pattern.

The wall in front of the village hall was most probably erected in 1878 - 9, at the same time as the hall and new bridge were built. The pillars to the front entrance are built in flint and tile to match the hall, with a new wall at either side.

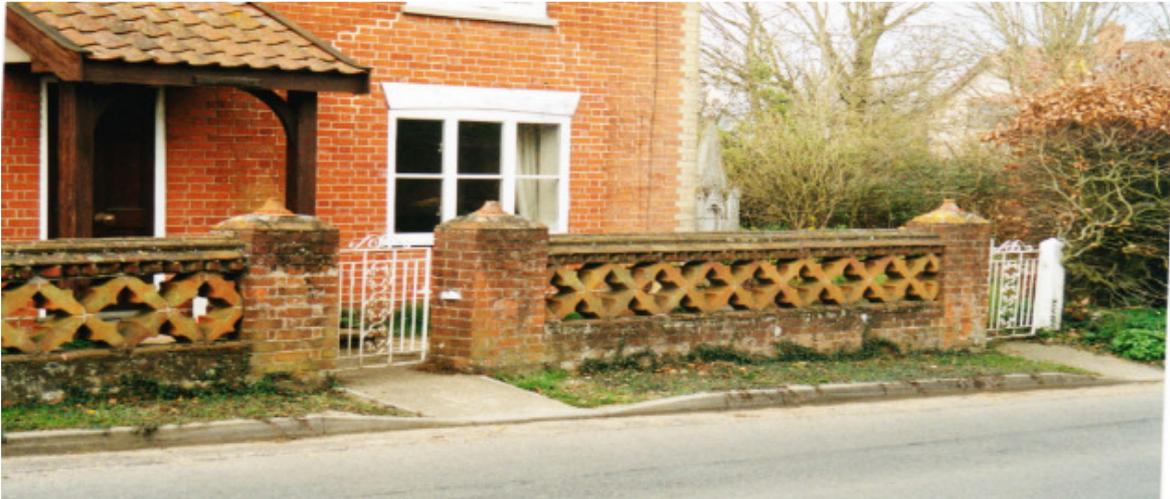
6. Abbey View

The third type has special bricks arranged in fours in a cross pattern, such as at Abbey View and Goldbrook House, to leave a quatrefoil shaped hole.

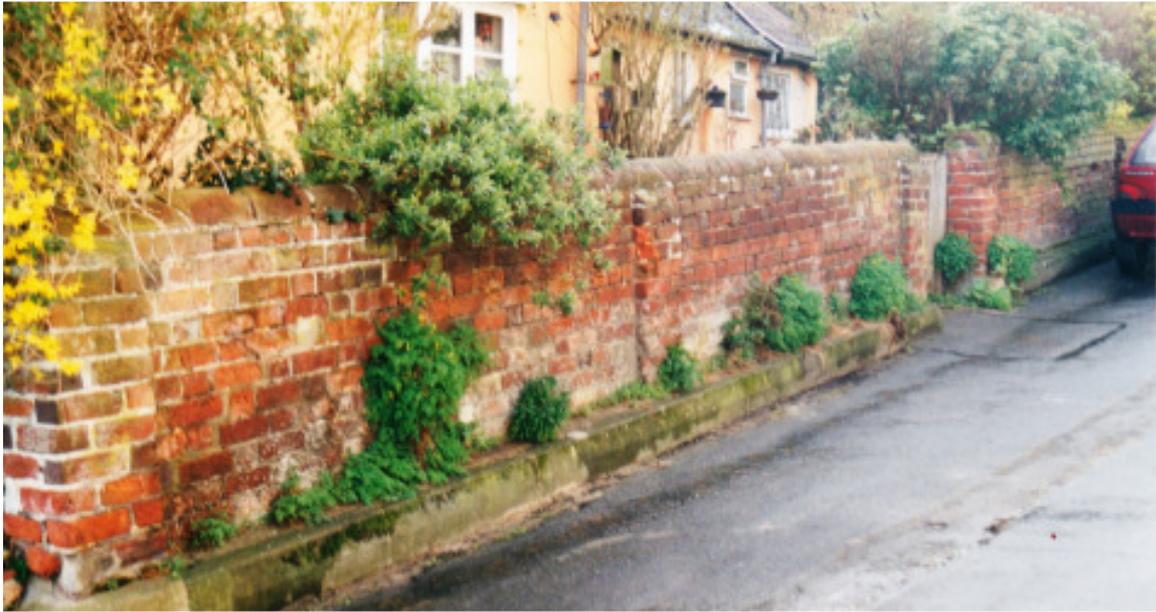
8. Church Hill West

We also noticed some of the plain walls, which traversed more than one property and had a distinctive large half round coping. The best examples were on Church Hill, continuous on one side from the Green up to Three Gables,

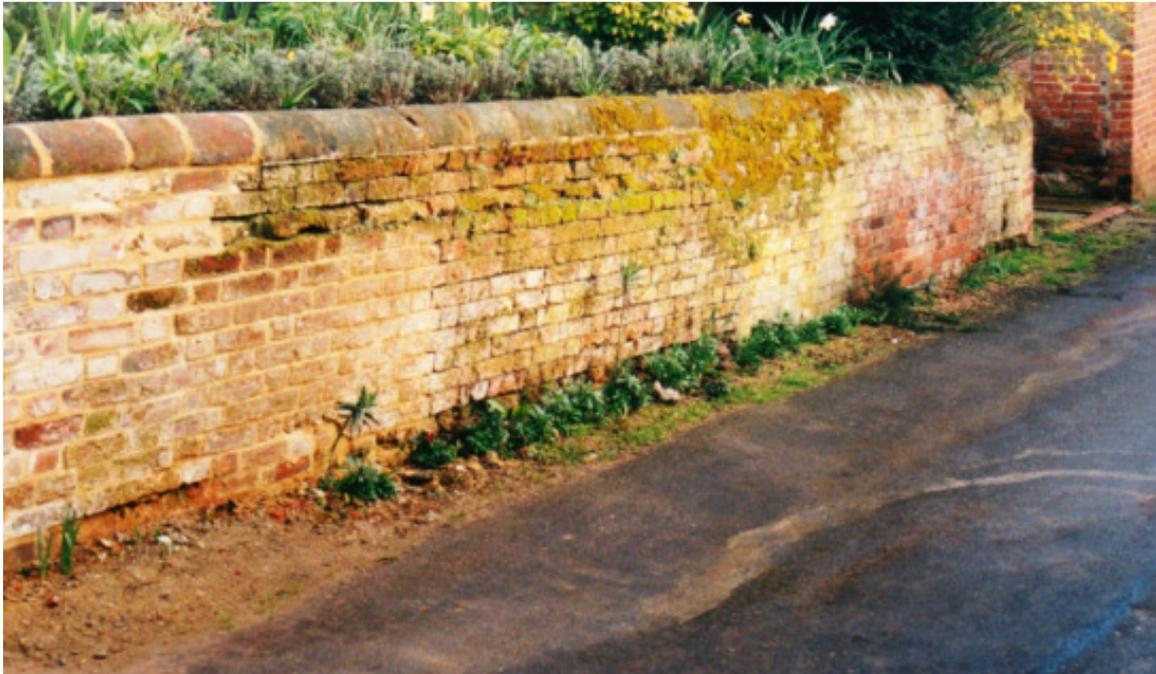
9. Little Park House in 1990's

and on the other side formerly running past Little Park House.

What happened at Little Park House has been noted. No 40, on the other side of the road, is not listed, so that wall is also vulnerable, so is the one at 44 Low St. More importantly Hoxne village hall itself is not listed - its only protection is ownership by the parish. The areas of most concern are nos 9-12 and 17-19 Cross Street, which are not listed and are so important to the street scene.

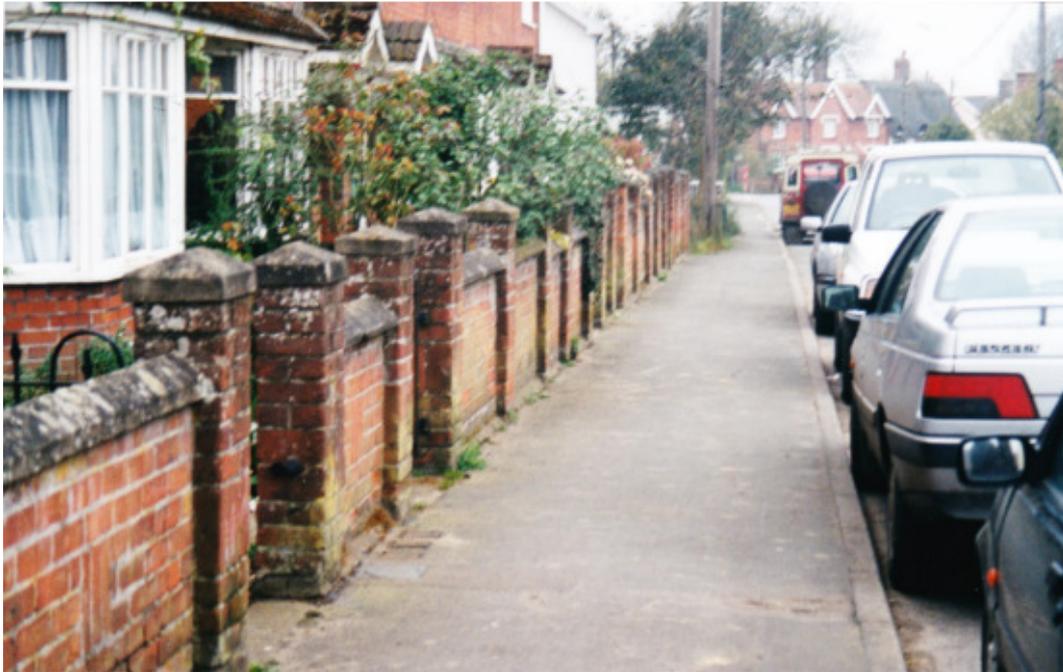
12. Banham Row

But, as the Banham family did not purchase the brickyard until 1925, probably the only wall that should be designated a Banham Wall is the continuous wall in front of the Banham Cottages on Cross St, built in 1934.

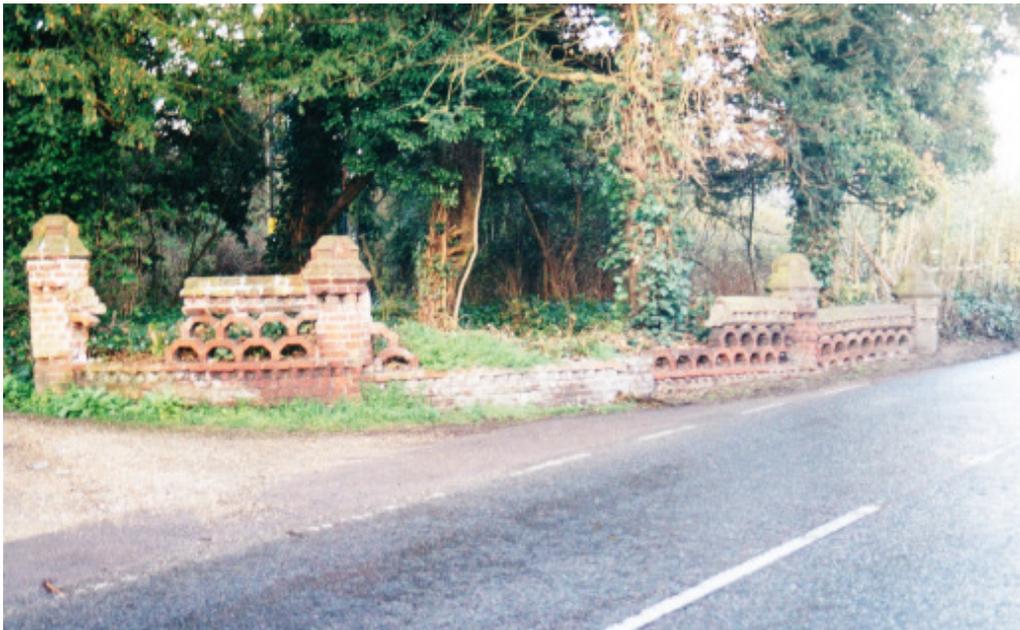
13. The Vicarage

The vicarage of course belonged to the church, but the Kerrisons had the advowson, or right to present the priest to the living – so there was a link.

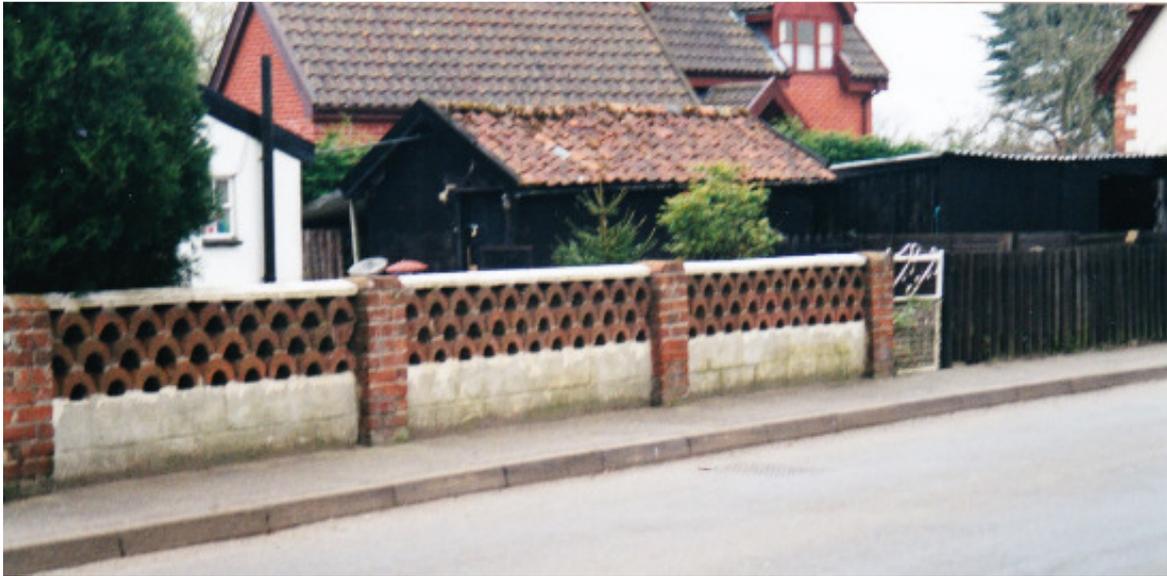
14. Ash View

At Ash View the brick wall is built on top of concrete blocks and is obviously modern, possibly reusing bricks from elsewhere.

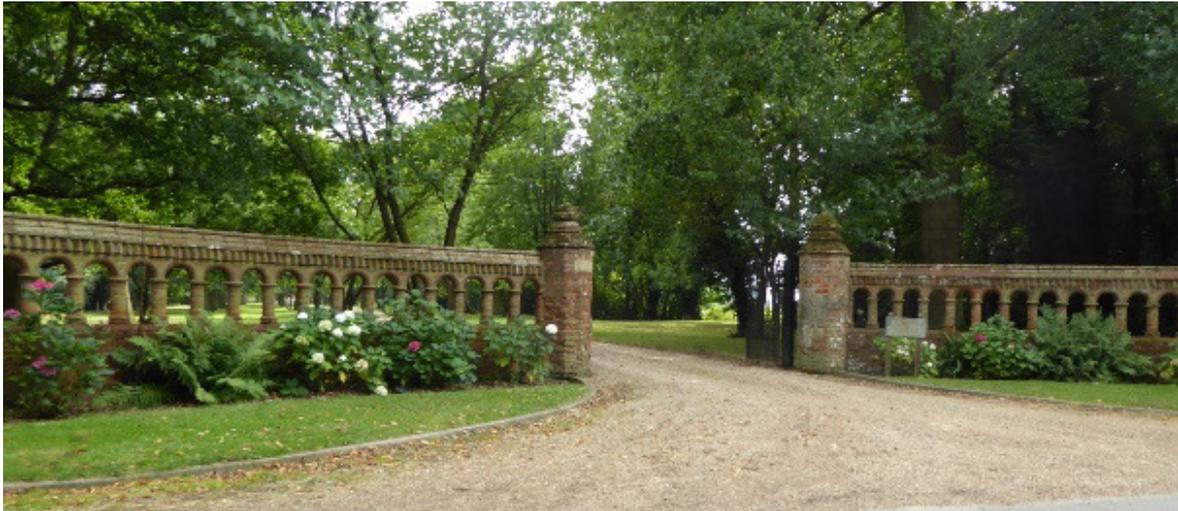
18. Brome Hall, with pillars These pillars are found nowhere else.

We cannot know how it all started. Did Kellaway commission some, and Lady Caroline later design the more high status elements, the quatrefoil type and pillars, which are relatively scarce? [Only Goldbrook House, home to the estate steward, Abbey View, home of the brickyard manager, Brome Hall and Church, and Monks Hall Syleham have the quatrefoils

and only Brome Hall itself has the pillars.] Whoever was responsible, it is likely the fashion for these walls belongs to the late Victorian era during the heyday of the brickyard.

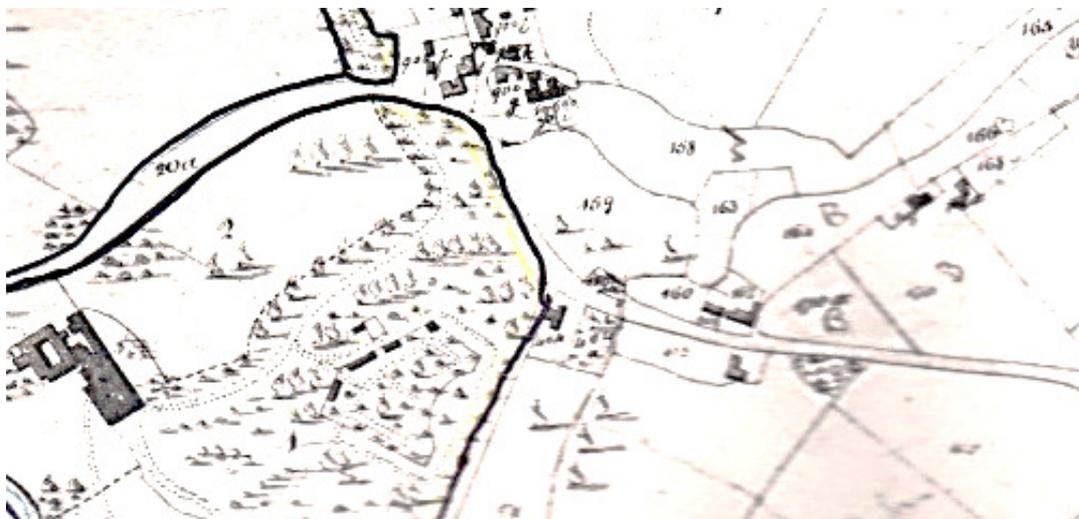
30. Tithe Map

Probably the only wall we can date for sure is the wall at Hoxne village hall. In the 1840's the site where the village hall would later be built was part of the large garden of the cottage to the south, as recorded on the Tithe Map.

This cottage and its present garden now has an old tall lime hedge fronting the road, which may have continued towards the bridge.

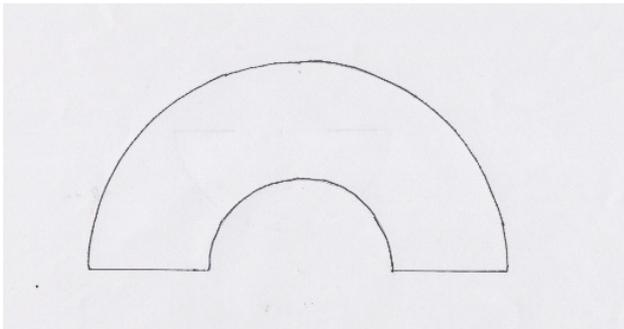
32. Half pipe bricks

The half-pipe bricks are crude and often not quite semi-circular. They were 6 inches deep, 9 inches across the base and 2 or 2 ¼ inches thick

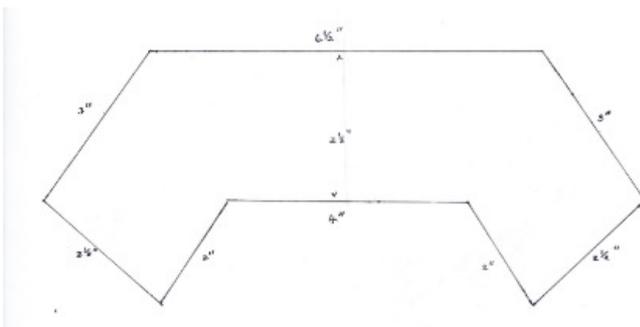
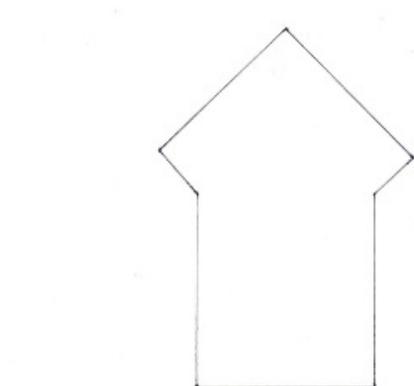
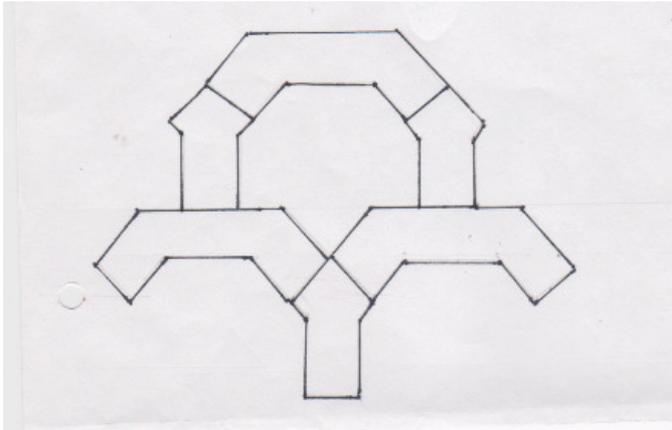
33. Village Hall bricks

The type used at the village hall to make a pattern were also 6" deep,

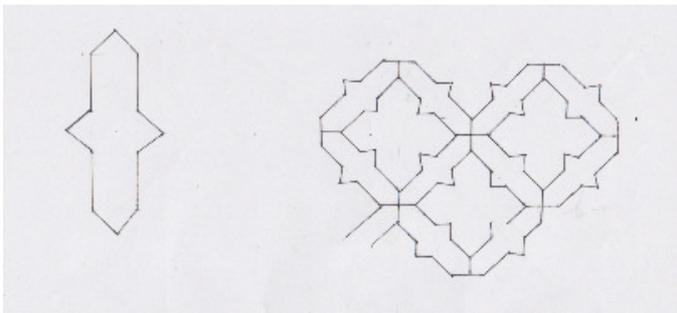
36. Cross/Quatrefoil type bricks

As were the cross/quatrefoil type.

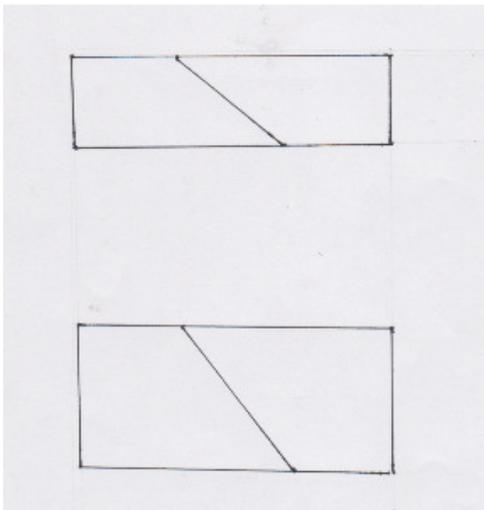
37. Diagonal cut

But there are other types which are less obvious. Bricks cut on the diagonal were used for dog tooth decoration.

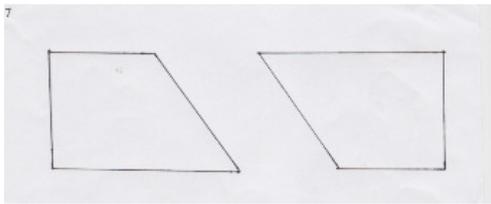
39. Base stones

There were also base stones. This drawing shows the profile of one of these – the diagonal being the front face of the brick - which could be used either way up.

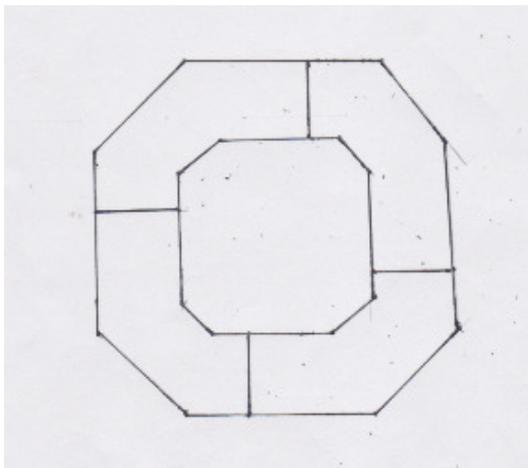
40. Brick with 3 angles

A brick with 3 angles was found in pillars at the Swan and Goldbrook House.

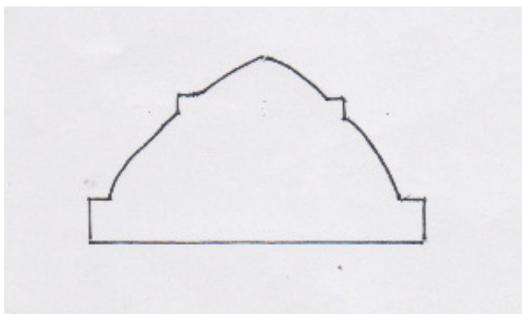
41. Ridged coping profile

There were also a variety of copings. The round coping has the same profile as the half pipe brick but is twice its length. The ridged coping was widely used on the ornamental walls.

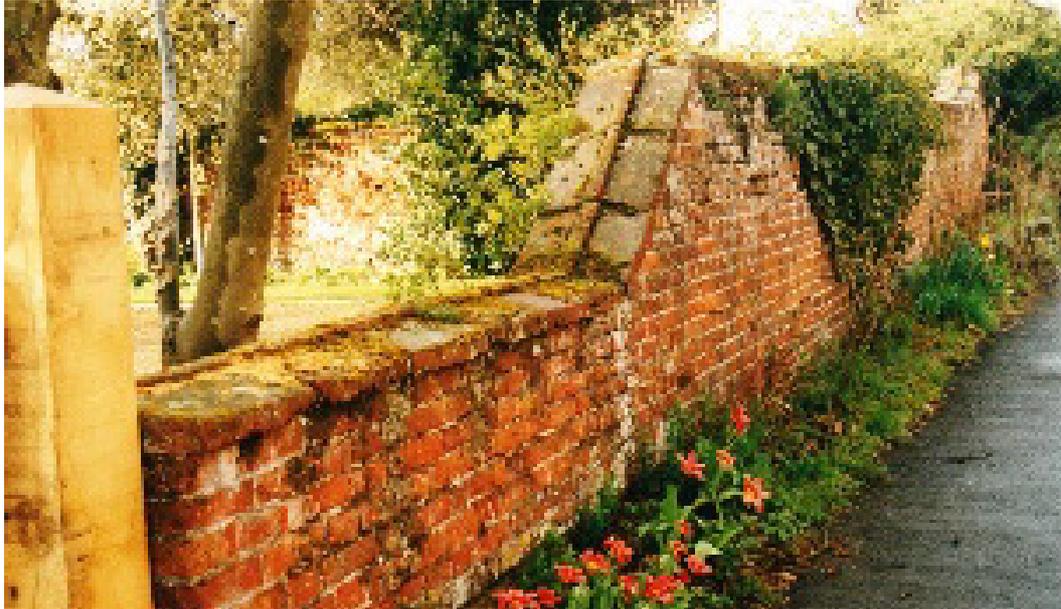
42. Swan coping

There was yet another type at the Swan.

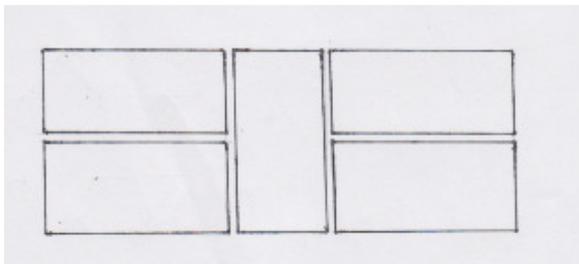
43. Flemish Bond seen from above

We looked at how the walls were built. The simplest was 3 or 4 courses of standard bricks laid in Flemish Bond [headers and stretchers] giving a depth of 9 inches.

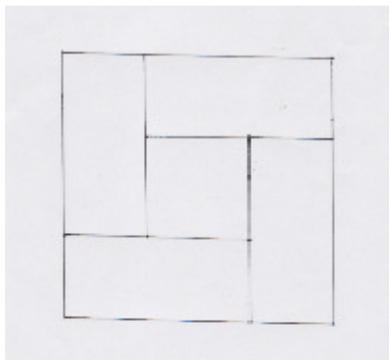
44. Simple pillar

Then courses of half pipe bricks, and a pillar of plain bricks , and a coping on top.

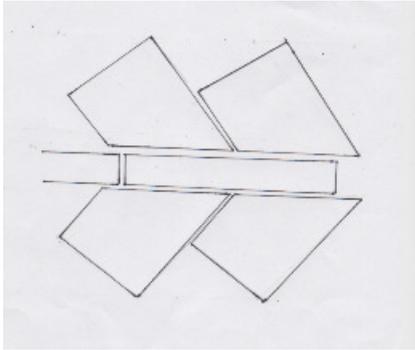
46. Dog tooth course

But some walls were more complicated than at first appears. The wall at the **village hall** has courses of standard bricks laid in Flemish Bond. Then a course laid diagonally for a dog-tooth decoration. But if you simply turn a 9" brick on the diagonal it does not project beyond the wall face. The builder had in fact cut bricks in half on the diagonal and laid them in a course with split bricks (probably rejects) used as a filler, so that the wall depth was now 10 – 11 inches, allowing for mortar.

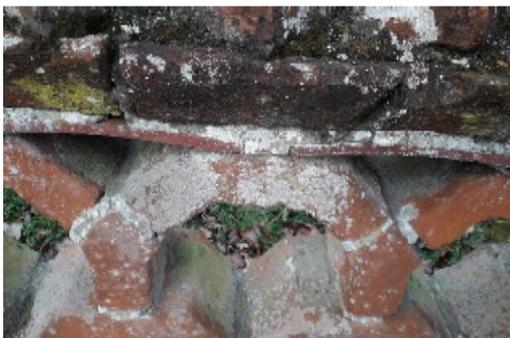
48. Tiles close up

Then a course of thin tiles 9 ½ inches by ½ inch to bridge the gaps above the special bricks and another course of base stones reversed so the longest edge is now at the top, giving a wide base for another course of dog tooth, topped off by another course of sloping base stones and the large ridged coping.

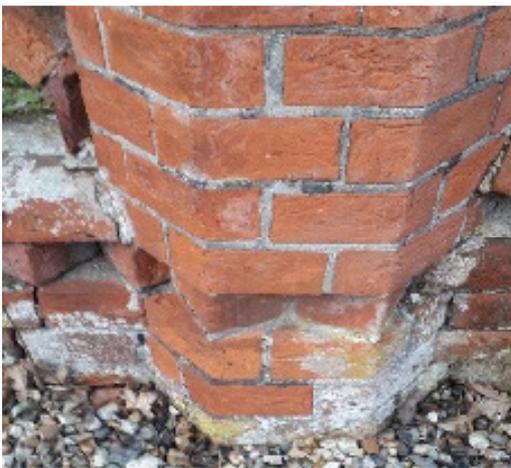
51. Pillar column

Most of the **pillars** are brick built using the bricks we have already seen. So the column uses angled bricks and has dog tooth courses.

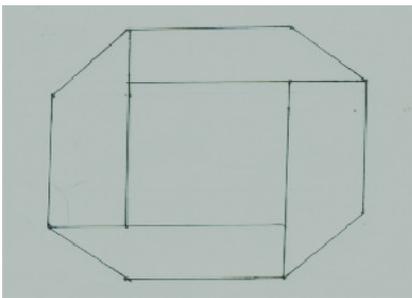
52. Pillar construction – unequal sides

At first it seemed the bricks were arranged like this, but in that case the sides would not be equal in length,

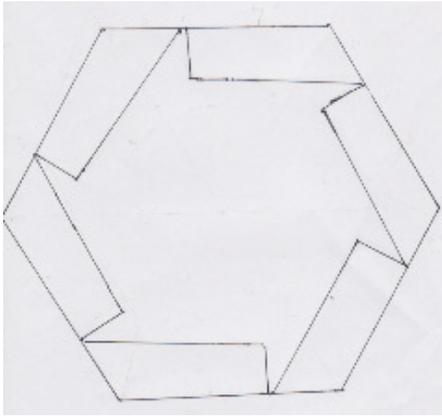
53. Pillar construction – equal sides

so the arrangement might be this.

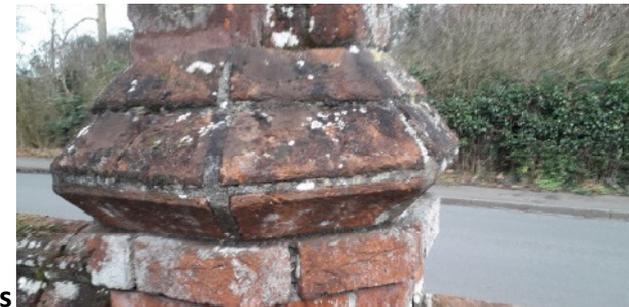
54. Pillar top – base stones

The tops of the pillars are also constructed from this repertoire of bricks. There are 3 courses of base stones

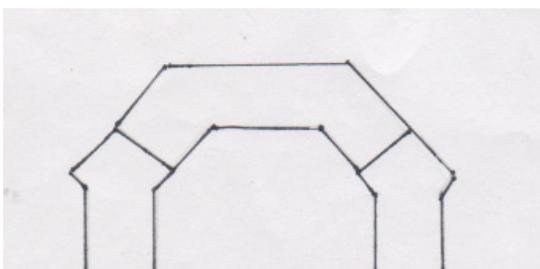
56. Pattern bricks drawing

then the pattern bricks arranged crosswise with pieces of brick to infill.

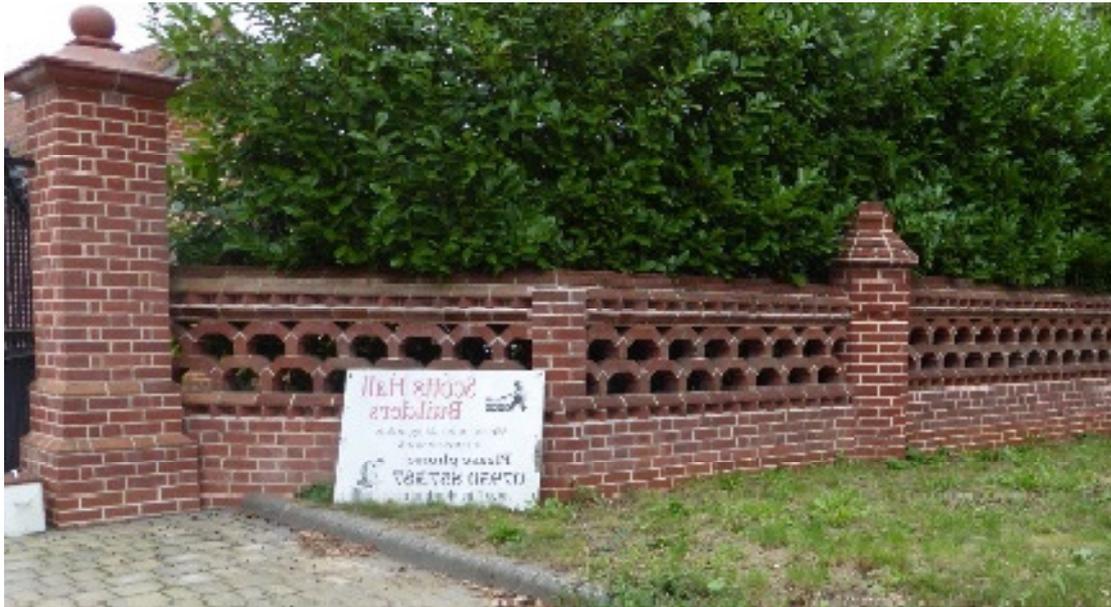
58. Horham

And the walls at Horham have been rebuilt in a modern brick, not the old red brick and look wrong.
