## Park Farmhouse, Hoxne, Suffolk

## Ground plan of Park Farmhouse, Hoxne, Suffolk

## 17th Century Barn at Park Farm, Hoxne, Suffolk

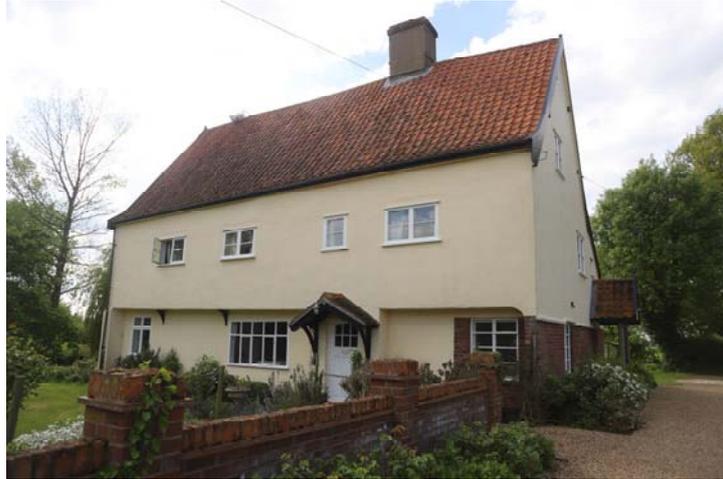
South front of Park Farmhouse

Park Farmhouse is a medieval two storey timber framed building that was built as a standing for viewing the deer in the medieval park which surrounds the building. It is 46ft by 21½ft on the ground floor, and jettied to the south front. The first floor seems to have been one single room, very tall and open to the roof with an unusual 4 bay bay structure. The west bay AB is 8ft long, then BC 9½ft, CD 17ft and the east bay DE 10½ft. The ground floor appears to have had a long east west partition creating a 5ft wide corridor along the south side of the building as shown on the reconstruction plan.

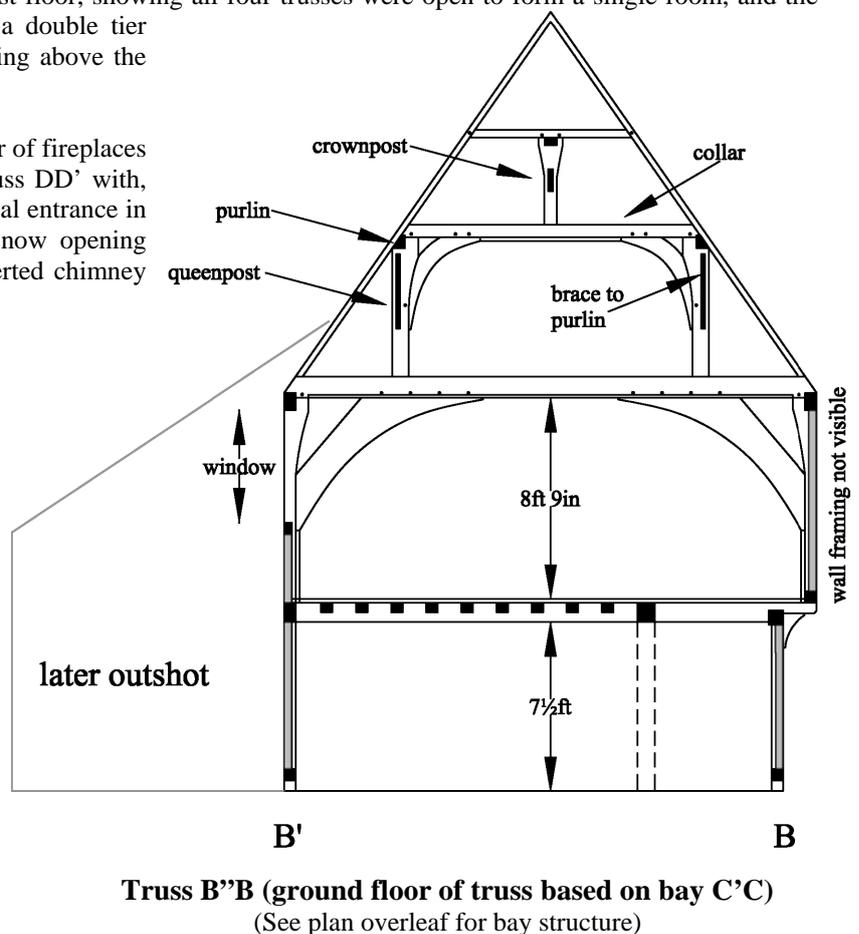
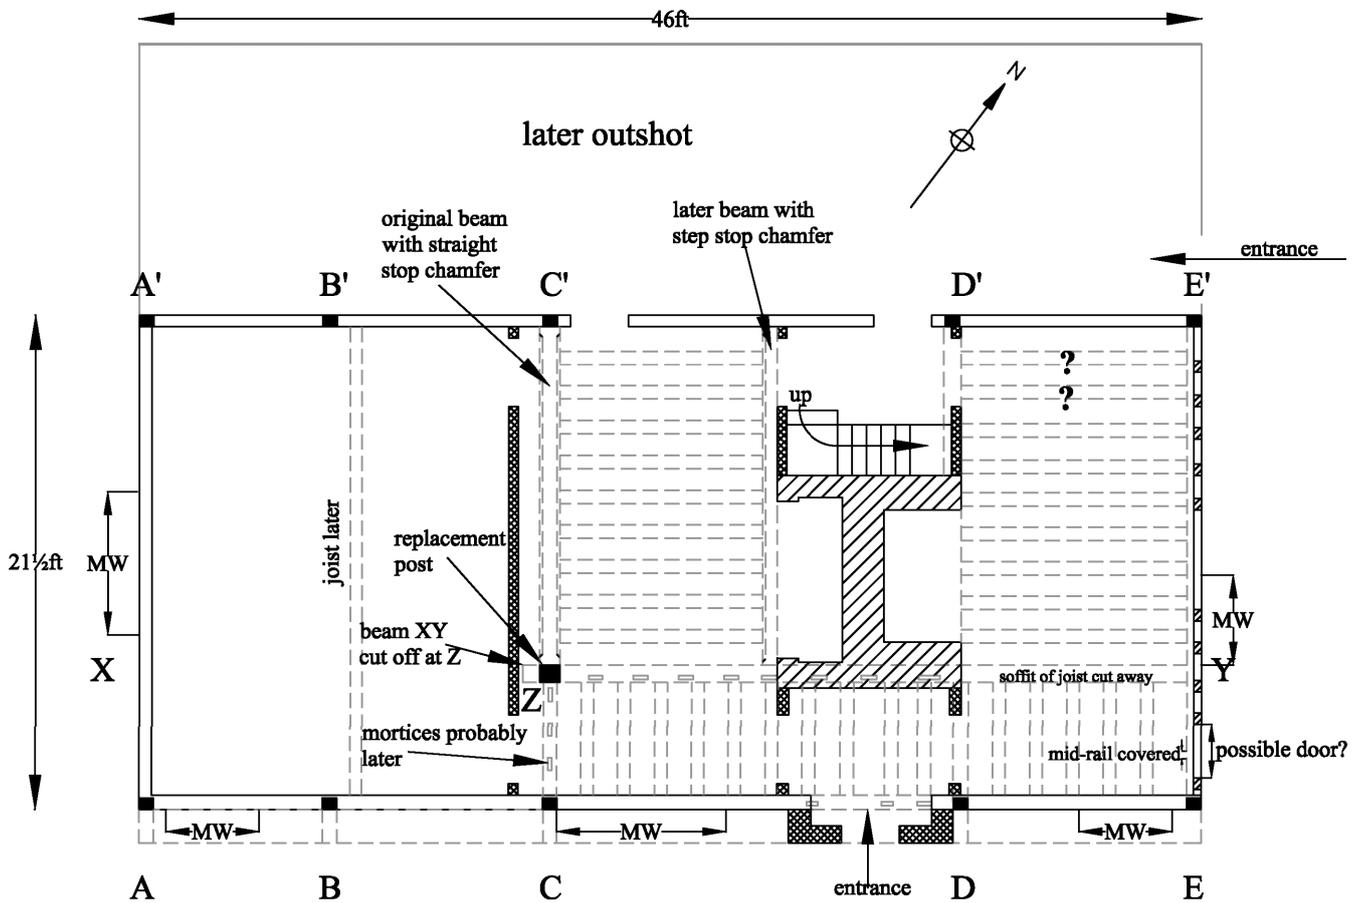
**Ground plan today - converted in 17th century into lobby entrance house**

Window 1st fl 2ft 5in wide  
 Window 1st fl 2ft 7in wide

In the 17th century a back-to-back pair of fireplaces were inserted on the south side of truss DD' with, what was possibly the original medieval entrance in the south front, being retained, but now opening into the lobby on the side of the inserted chimney stack, creating a lobby entrance house. Stairs were added on the north side of the chimney stack, probably a circular stairs. They have since been made straighter up to the first floor, but circular stairs survive continuing from the first floor up to the attic. Partitions were added on both the ground and first floors to create three rooms on each floor. Part of the collar purlin was removed to make way for the inserted chimney and an additional queenpost was added against the west side of the stack to support the collar purlin. This was made of re-used timber including a crenellated beam being used for the collar. Late an outshot was added along the north side and additions made to the outshot in the 20th century.

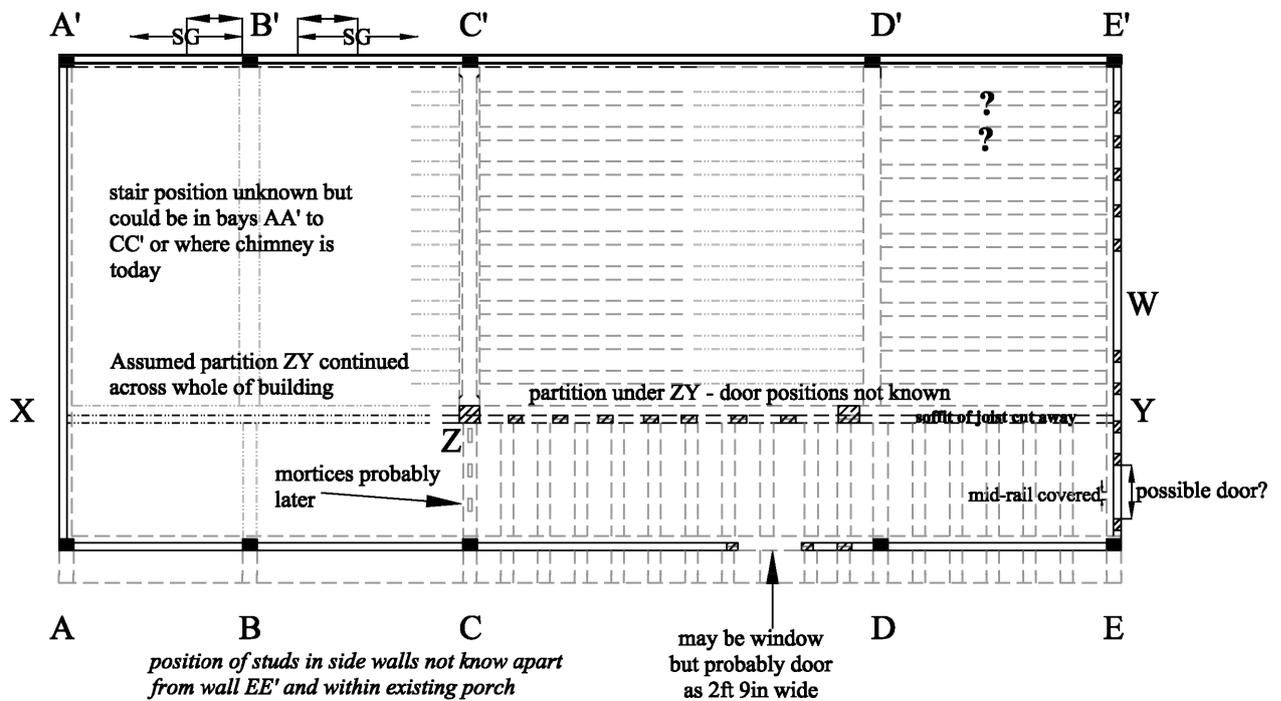
**Reconstruction of Ground plan when built in 15th century**

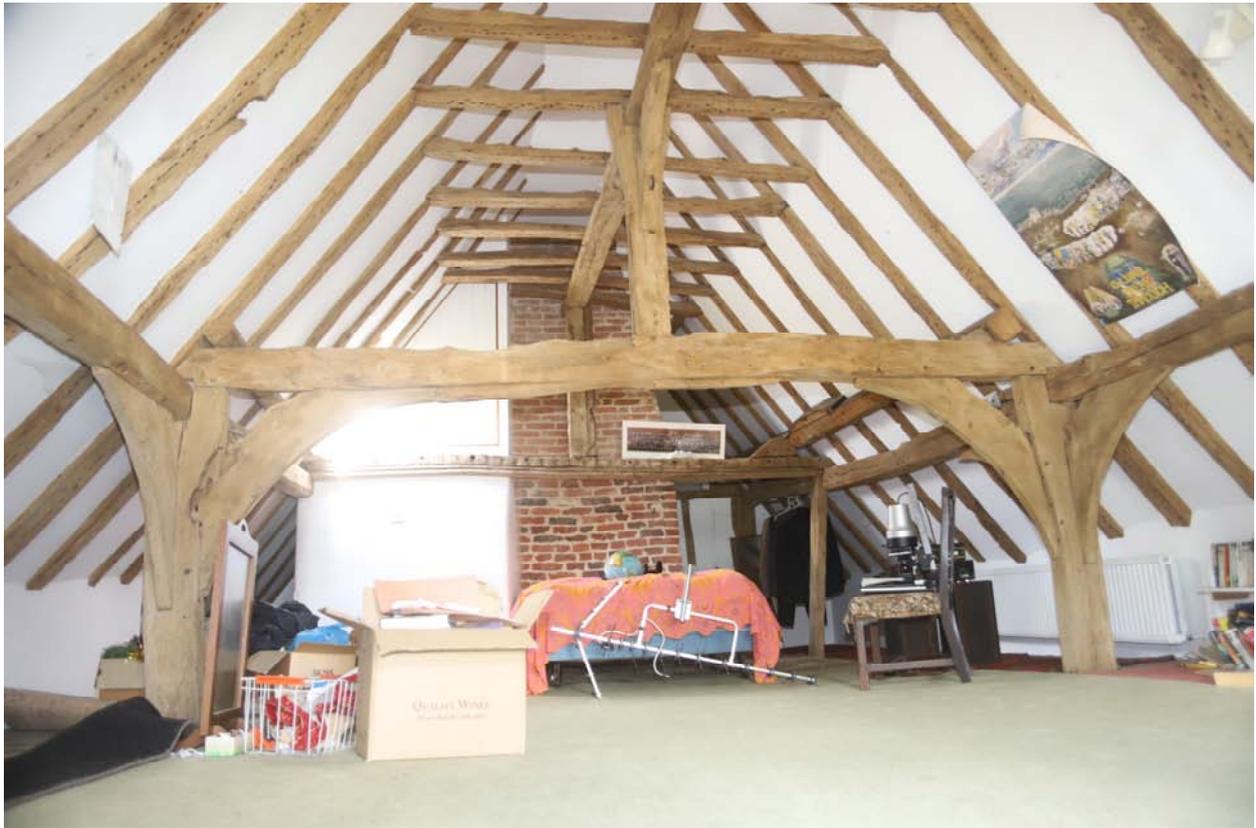
Two tier queenpost roof with crownpost above looking east to inserted chimney

One difficulty with interpreting this building is that very little of the timber framing is visible on the ground floor, apart from the ceiling in the eastern half. The ceiling in the western half has been rebuilt. The east-west partition probably continued though the western half, but one can not be certain as no other building has been recorded with this layout. More is visible on the first floor, showing all four trusses were open to form a single room, and the beautiful roof survives intact. It is a double tier queen post roof with a crownpost rising above the queenpost collar.

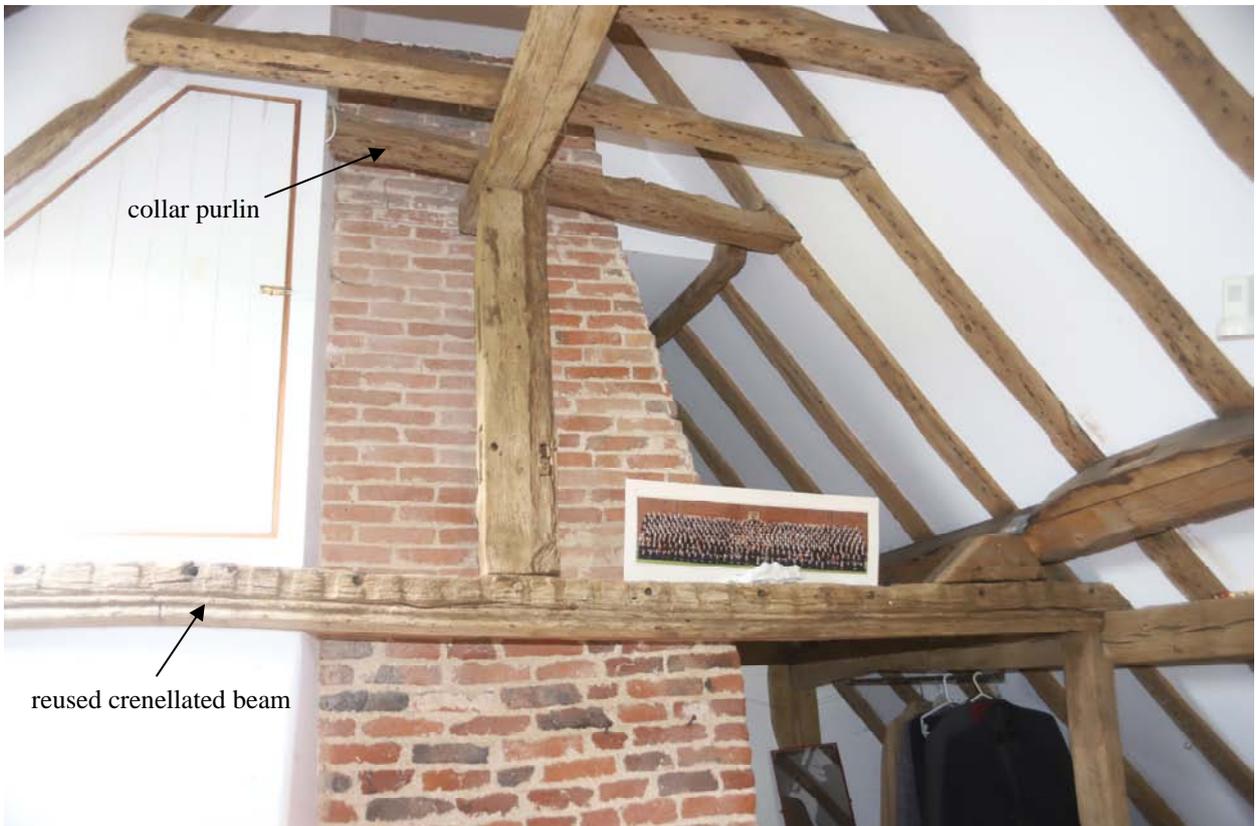
Additional queenpost truss inserted in 17th century to support truncated collar purlin with a re-used crenellated beam for the collar

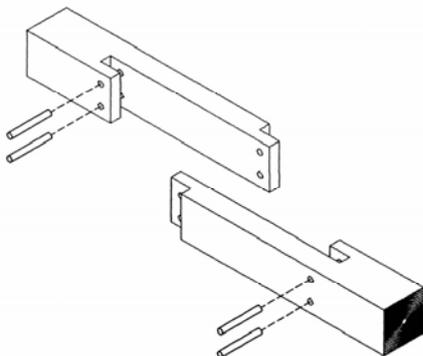
Fig 3: Face halved and bridled scarf joint (this joint appears in the late 16th century, but comes into common use from the second quarter of the 17th C)

To the south of the farmhouse is complex of barns forming a ‘T’ shape extending to the north with lower buildings behind on the south side (Fig 1). The top of the ‘T’ running west to east is a 17th century barn with jowled posts and drooping braces (Fig 2) and face halved and bridled scarf joints (Fig 3), the type that became the main scarf joint from the 17th century onwards.

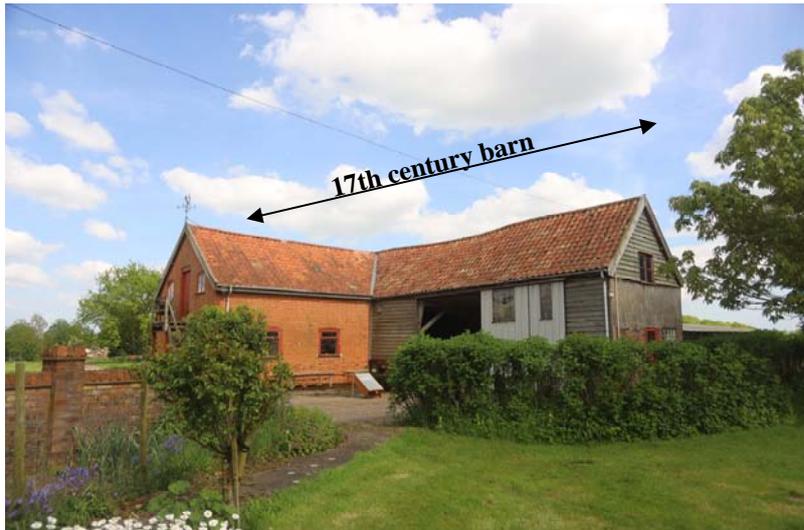
Fig 1: North front of barn complex at Park Farm, Hoxne

Unfortunately it is not safe to see the upper part of the barn in Fig 2, but parts of the framing are visible in the east end (that to the left of the brick wing in Fig 1).

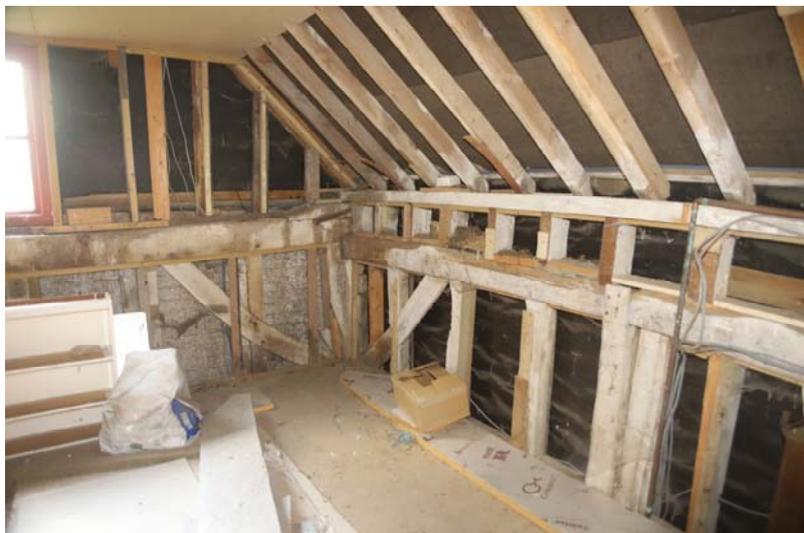
Fig 2: North-west corner of 17th century barn

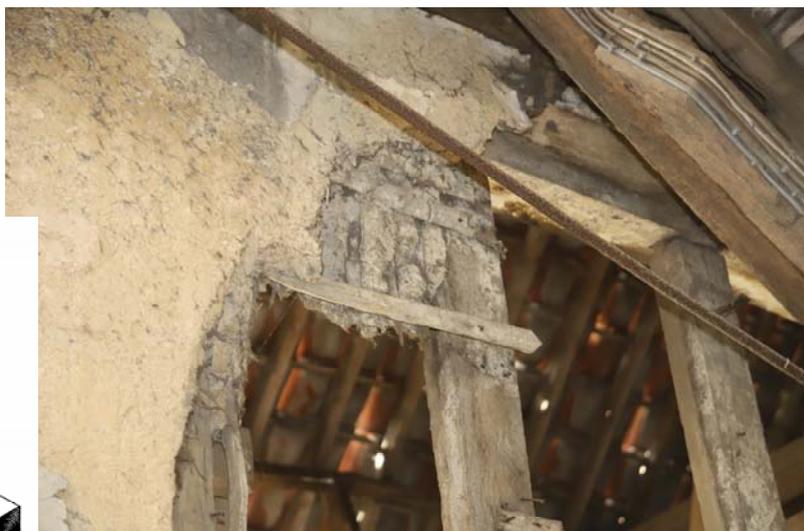
Fig 4: Exterior of east end of south wall of 17th C barn

On the rear south wall part of the wattle and daub infill survives (Fig 4). The exterior was completely plastered over by nailing horizontal laths to the exterior of the studs as in Fig 4, with vertical wattle rods fitted between the studs and tied to the laths. The daub was then applied to the exterior covering the studs and laths while, on the interior, the daub was applied to the vertical rods between the studs, leaving the studs visible internally. As can be seen there are no marks on the side of the studs and, where the exterior covering has been removed there is no visible evidence of there having been wattle and daub infilling between the studs.
