## Note on Architecture of 37-39 Church Hill, Hoxne, Suffolk

# Reconstruction of 37-39 Church Hill, Hoxne, Suffolk

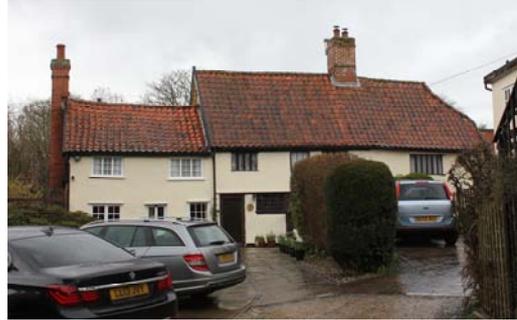
Fig 1: East front of 37-39 Church Hill

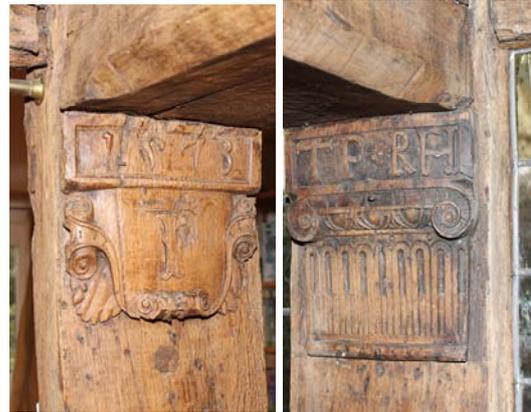
Fig 2: Date 1573 on west post

Fig 3: TP RH on east post

37-39 Church Hill is a timber framed house built in three phases. The higher range to the right, consisting of the hall and parlour with chambers above, was built in 1573, the date carved on the shield on the west post of the hall's centre truss (Fig 2 & drawing a). It was built for the unidentified TP and RH, the initials on the shield in the east post of the centre truss (Fig 3). The lower range to the left, which replaced an earlier service range, was built in the 17th century as a single storey wing, and was raised to its present height in the 18th or 19th century. Additional later ranges have been added to the rear of the building.
