Beech Cottage

6.1.22

HOXNE LOW STREET (west side) TM 17 NE 7/102 Aldersyde, The Cottage & adjoining cottage to north 29.7.55 (previously listed as Aldersyde, Two cottages adjoining Aldersyde) GV II Originally one dwelling, now 3 cottages. C16, in several phases, with later alterations. Timber framed and plastered, with old panelled plasterwork to front. Pantiled roof. 2 storeys. A single long range with continuous jetty to road frontage. 5 windows, mainly C18 3-light casements. Set forward to extreme right is a C19 plastered and gabled one-storey addition with old 4- light window. In the centre of the range is a canted small-paned former shop window of c.1800. Aldersyde has a C19 4-panel door, The Cottage has a C19 4- panel raised and fielded door, right hand cottage has a C20 door; all are reached by short flights of steps. 2 internal stacks, that to left an C18 insertion with cross-axial shaft. The frame is in 7 bays. There is evidence for extensive remodelling during C16, the rear wall older than the remainder. End bay to left (bay 1) was a carriage entrance, the upper floor set high; later infilling, with a false jetty to match the remainder. Bays 2 and 7 have one-bay rooms w

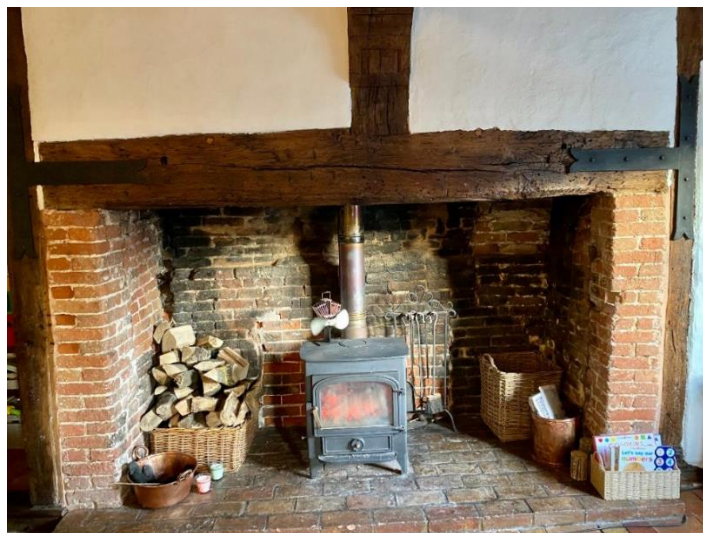
First floor North room, large fireplace with bressummer 2.8m long.

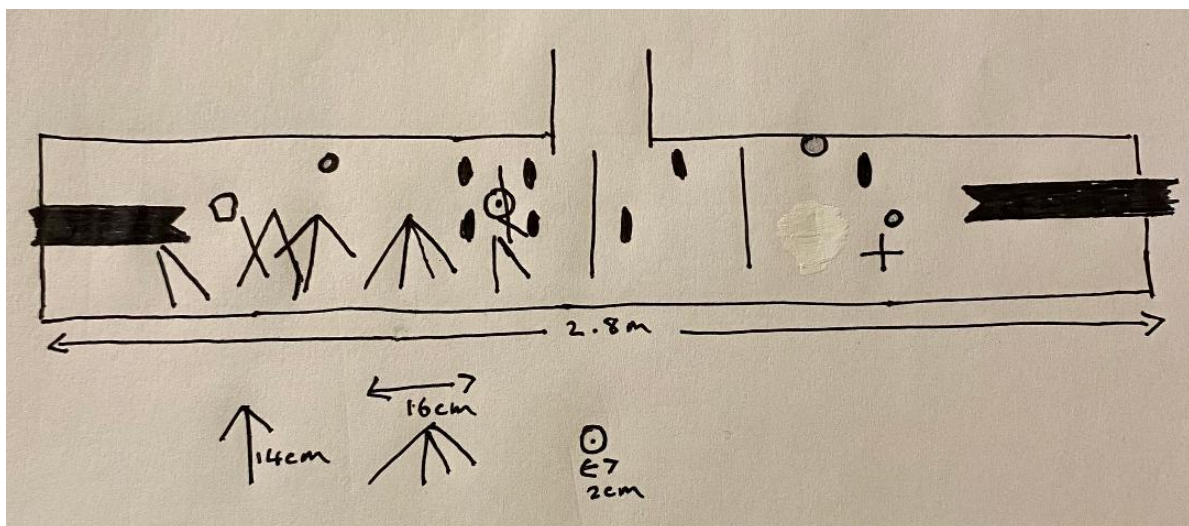
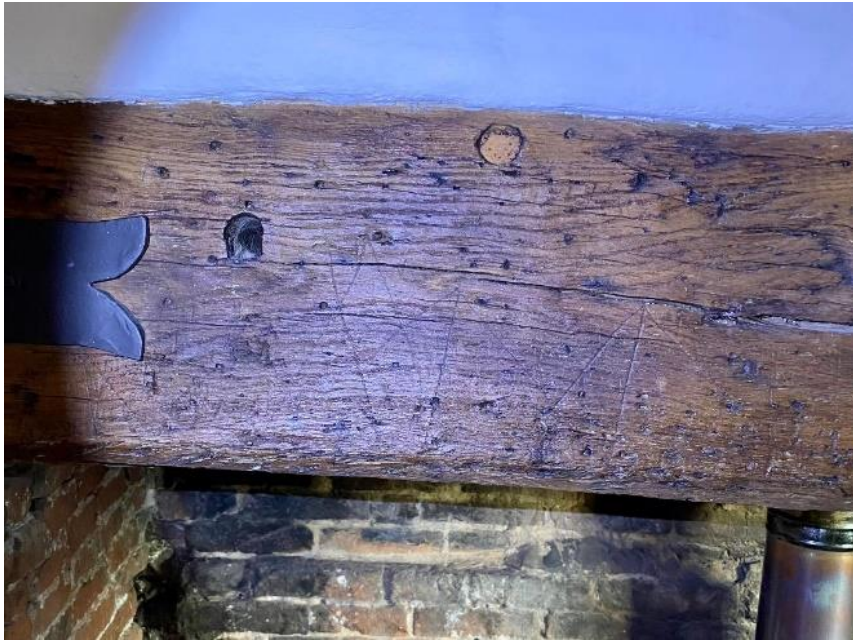
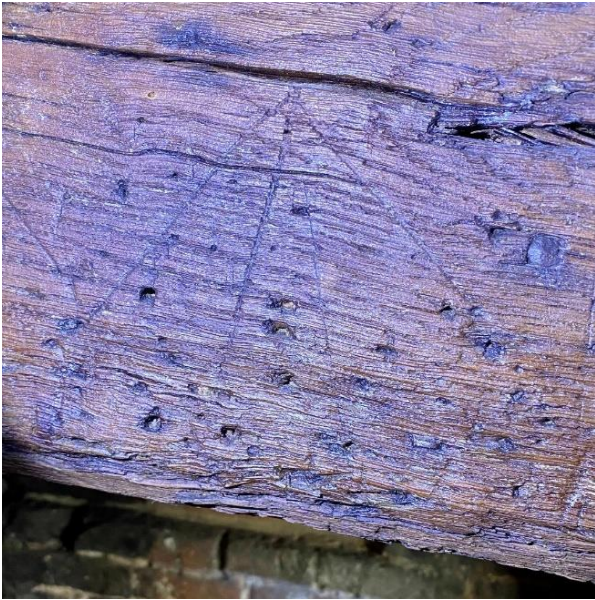
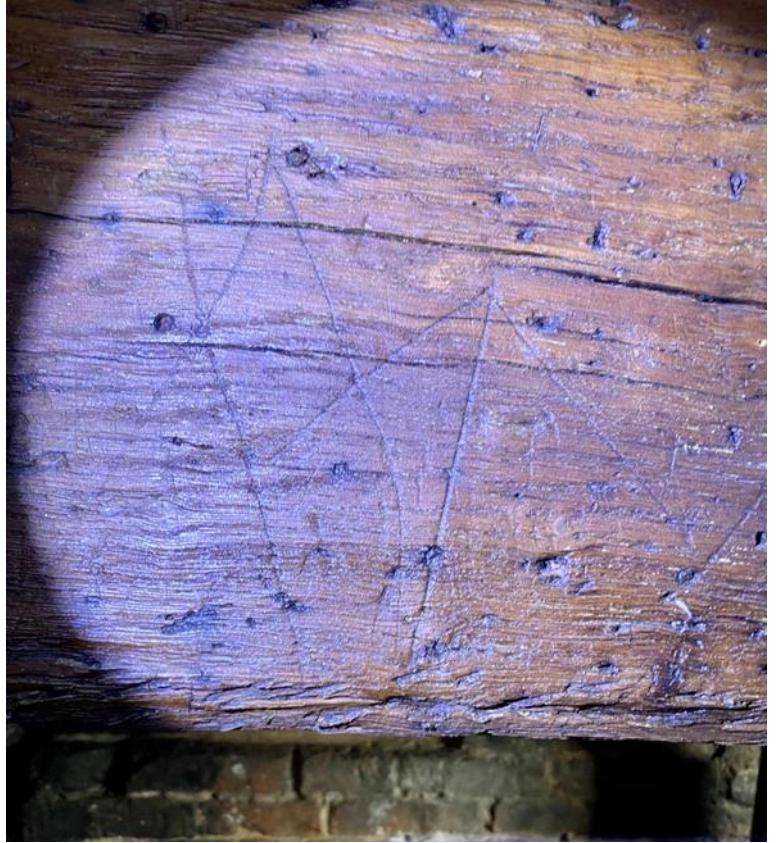
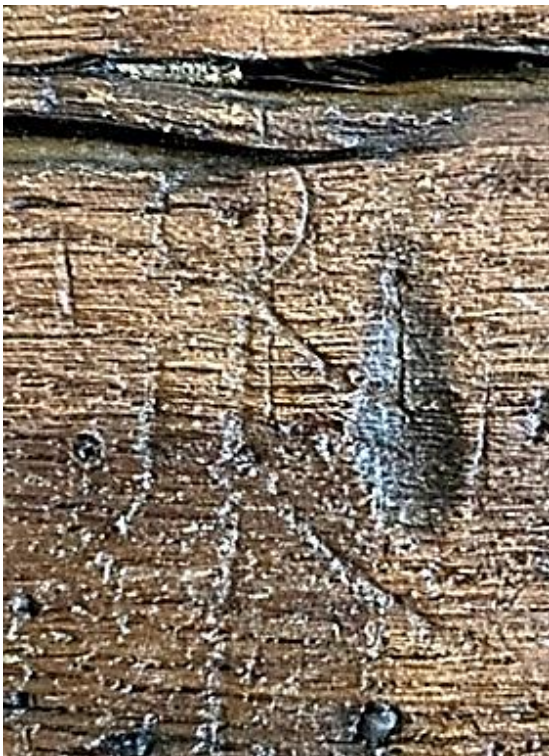
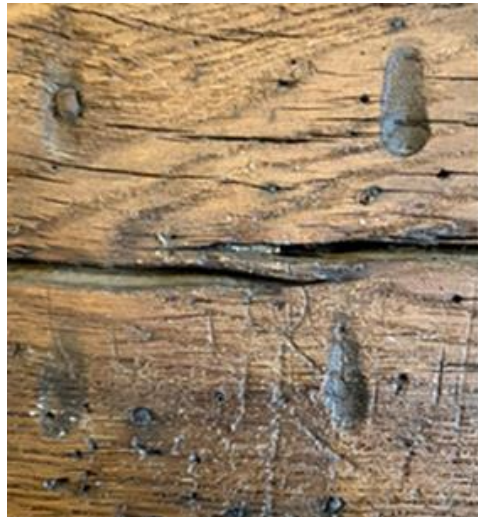
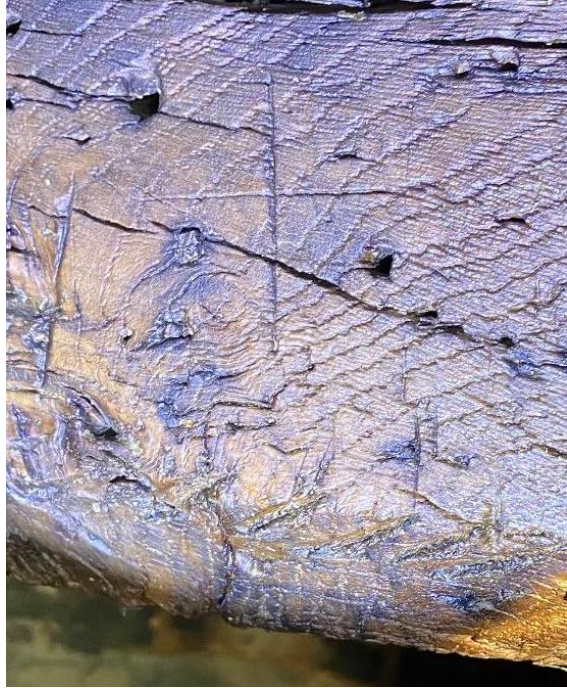
9 burn marks, Large M 16cm wide, arrow 14cm tall A or partial M. Compass drawn circle inside cluster of burn marks. Symmetrical (Greek) cross 5cm wide on East side of beam.

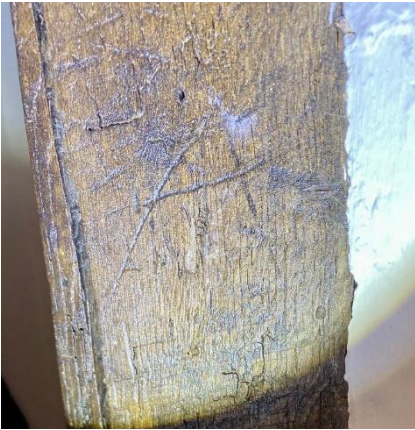
Cross passage

On the west frame of dearne door (blocked) crude A?

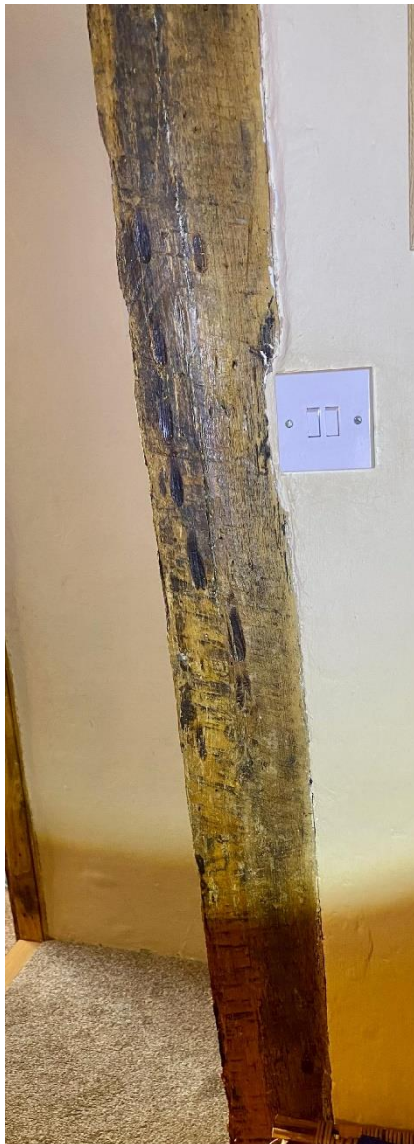
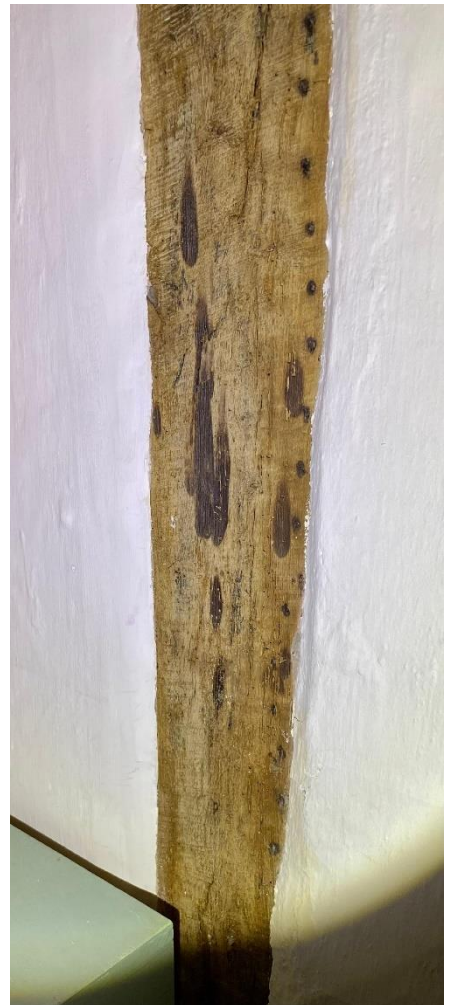
First floor

No apparent marks in the rooms except carpenter marks but many burn marks around door frames (East – 6, and West side, 10) and in the bathroom on south wall beams (19).
